**SITE INSPECTION EXPANDED TRIP REPORT  
FOR  
JARD COMPANY, INC.  
SITE REASSESSMENT  
BENNINGTON, VERMONT**

**EPA REGION I SUPERFUND PROGRAM  
TRIP REPORT/CHECKLIST**

**Site Name:** Jard Company, Inc.  
**Address:** 259 Bowen Road  
**Town:** Bennington  
**State:** Vermont (VT)

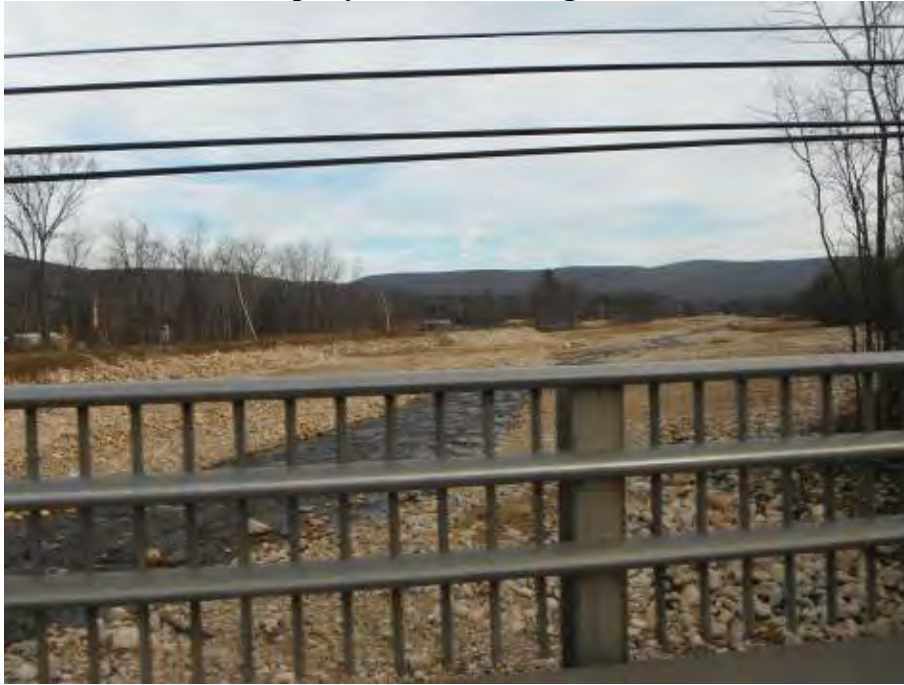
**FRAME NUMBER:** DSCF1410.JPG  
**PHOTOGRAPHY BY:** G. Hornok

**SCENE:** View, from right to left, of Walloomsac River, the berm, and the former Jard Company, Inc. (Jard) facility from the Park Street Bridge. Photograph taken facing east.

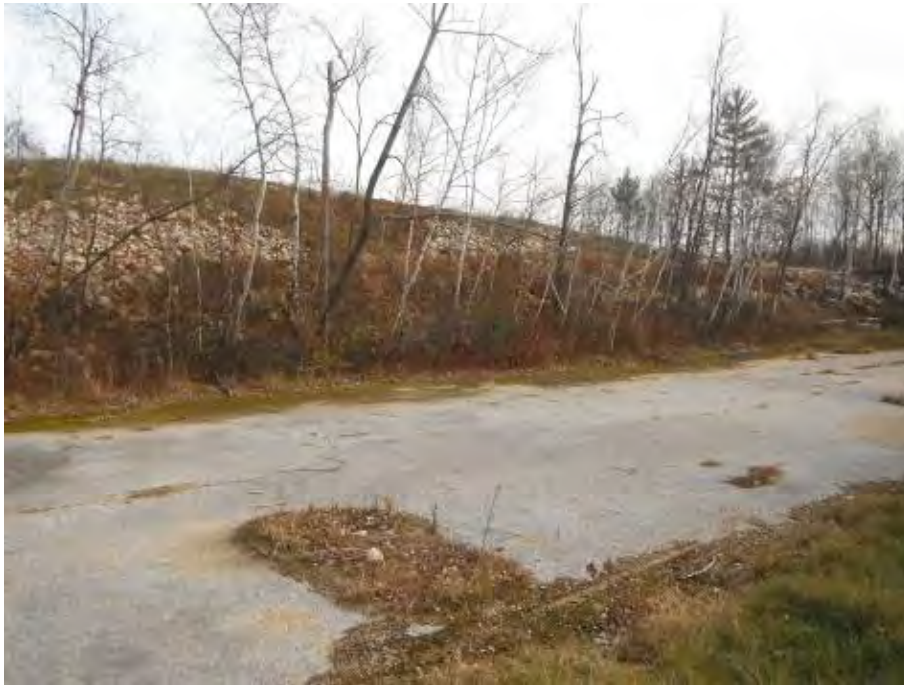
**FRAME NUMBER:** DSCF1417.JPG  
**PHOTOGRAPHY BY:** G. Hornok

**SCENE:** View, from background to foreground, of the southwestern edge of the excavated material pile, tree line, existing asphalt parking area used as a staging area by START, and a portion of the earthen cap material. Photograph taken facing southeast.

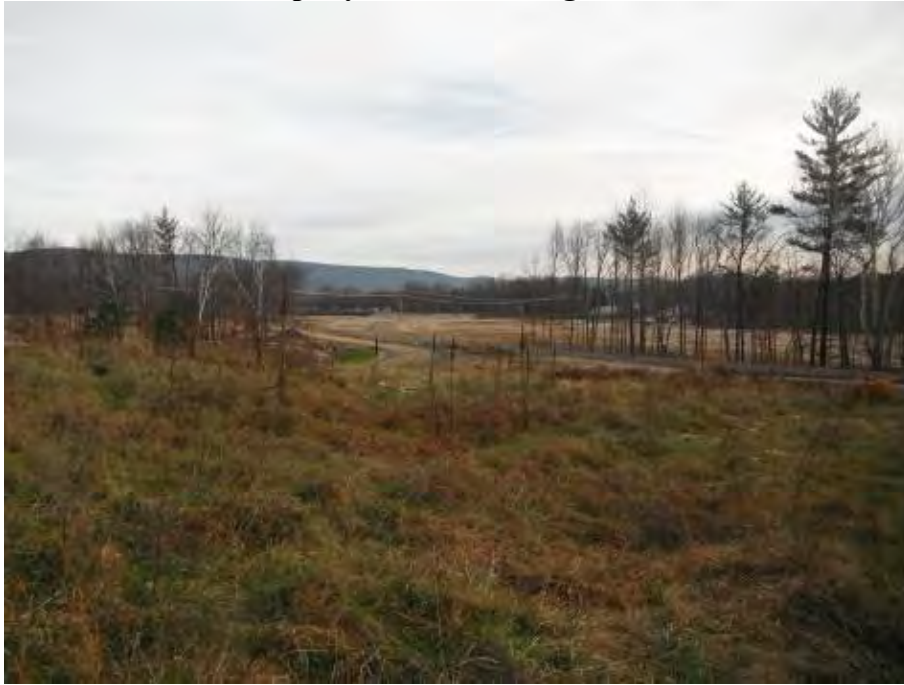
**FRAME NUMBER:** DSCF1420.JPG  
**PHOTOGRAPHY BY:** G. Hornok

**SCENE:** View of the top of the excavated material pile with vegetative cover, earthen berm, and the Walloomsac River in the background. Photograph taken facing southeast.

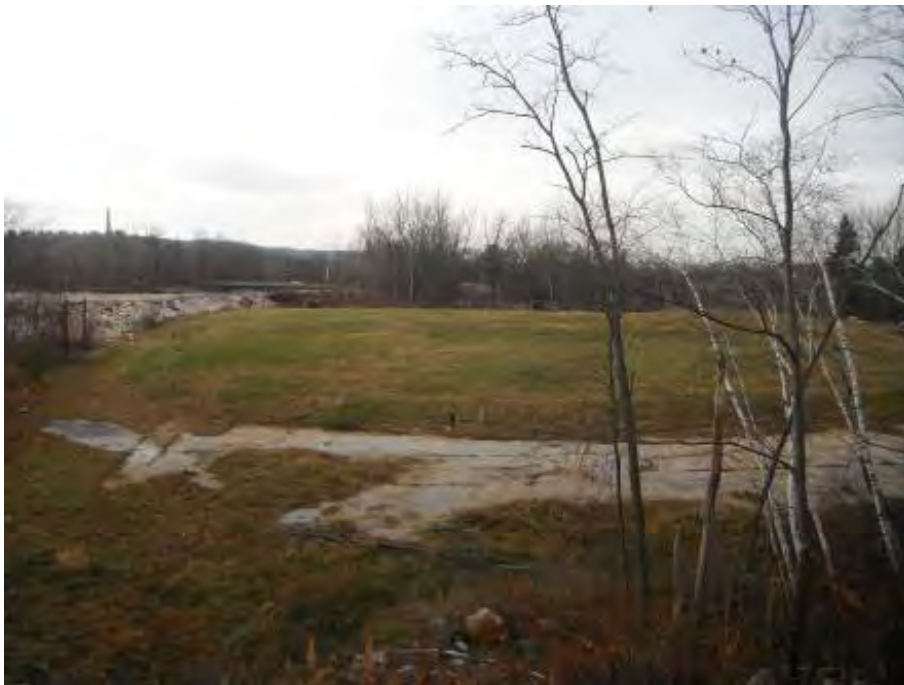
**FRAME NUMBER:** DSCF1421.JPG  
**PHOTOGRAPHY BY:** G. Hornok

**SCENE:** View of the former Jard facility location, taken from the top of the excavated material pile. The asphalt parking area used as a staging area by START during sampling activities is visible in the foreground; to the left near the berm is a structure formerly used to hold transformers. Several monitoring well stick-up casings located in the southwest corner of the earthen cap are also visible. Photograph taken facing west.

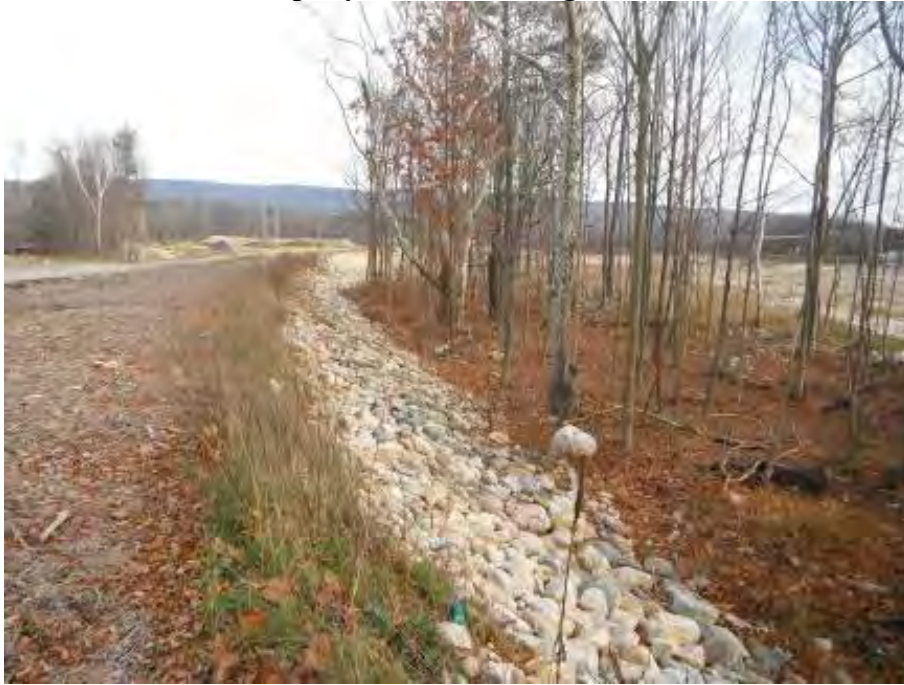
**FRAME NUMBER:** DSCF1422.JPG  
**PHOTOGRAPHY BY:** G. Hornok

**SCENE:** View of the berm separating the former Jard Company, Inc. property and the excavated material pile from the Walloomsac River. Photograph taken facing east.

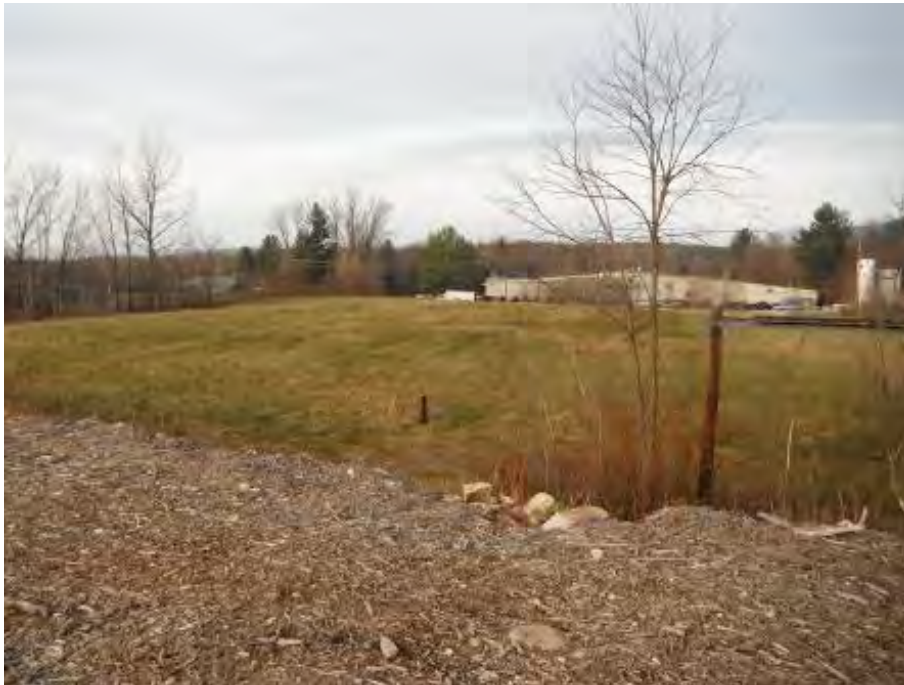
**FRAME NUMBER:** DSCF1425.JPG  
**PHOTOGRAPHY BY:** G. Hornok

**SCENE:** View of the former Jard facility with earthen cap from the top of the berm. A monitoring well casing and the transformer structure are visible in the foreground. In the background is an operating industrial facility. Athletic fields are located to the west. Photograph taken facing north.

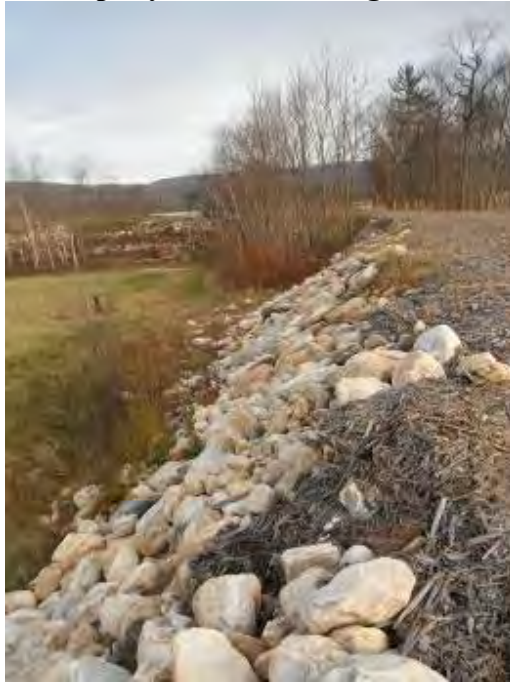
**FRAME NUMBER:** DSCF1426.JPG  
**PHOTOGRAPHY BY:** G. Hornok

**SCENE:** View of the southern edge of the former Jard facility, along the berm. The southwestern corner of the excavated material pile is visible in the background. Stick-up casing for MW-3/MW-3D in the earthen cap is also visible. Photograph taken facing east.

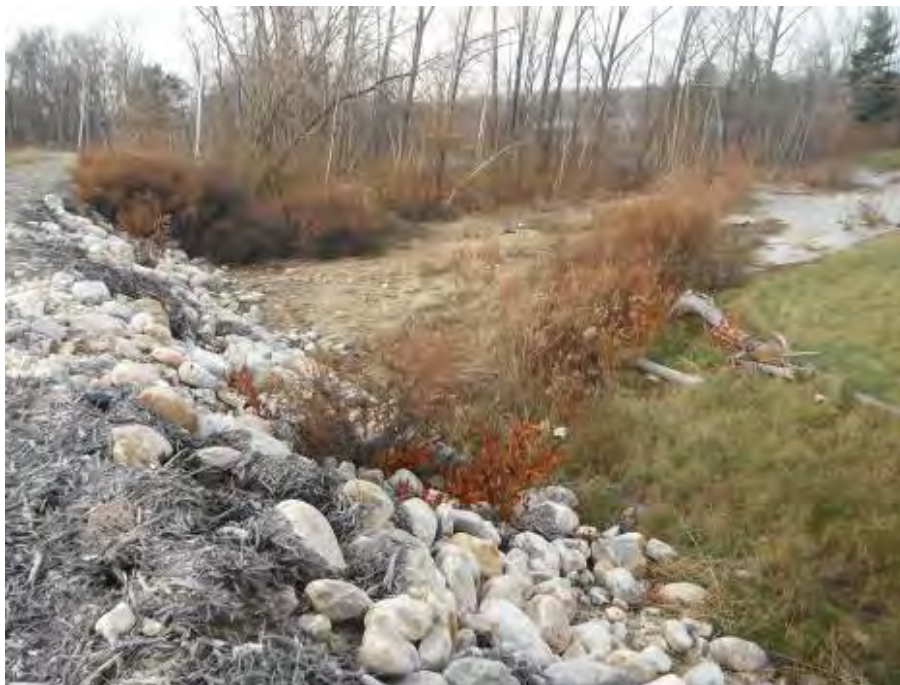
**FRAME NUMBER:** DSCF1428.JPG  
**PHOTOGRAPHY BY:** G. Hornok

**SCENE:** View of the southwest corner of the former Jard facility and the northern edge of the berm. Several source samples were collected along the tree line which separates the Jard property from the athletic fields (background). Photograph taken facing west.

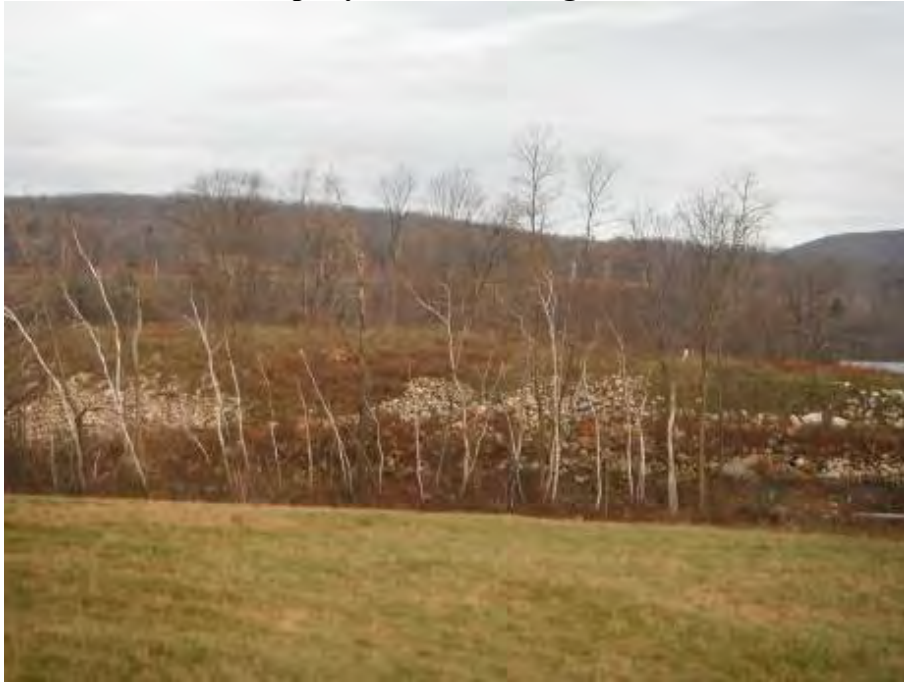
**FRAME NUMBER:** DSCF1429.JPG  
**PHOTOGRAPHY BY:** G. Hornok

**SCENE:** View of the former Jard facility with earthen cap (foreground); the western edge of the excavated material pile is visible east of the tree line (background). Photograph taken facing east.

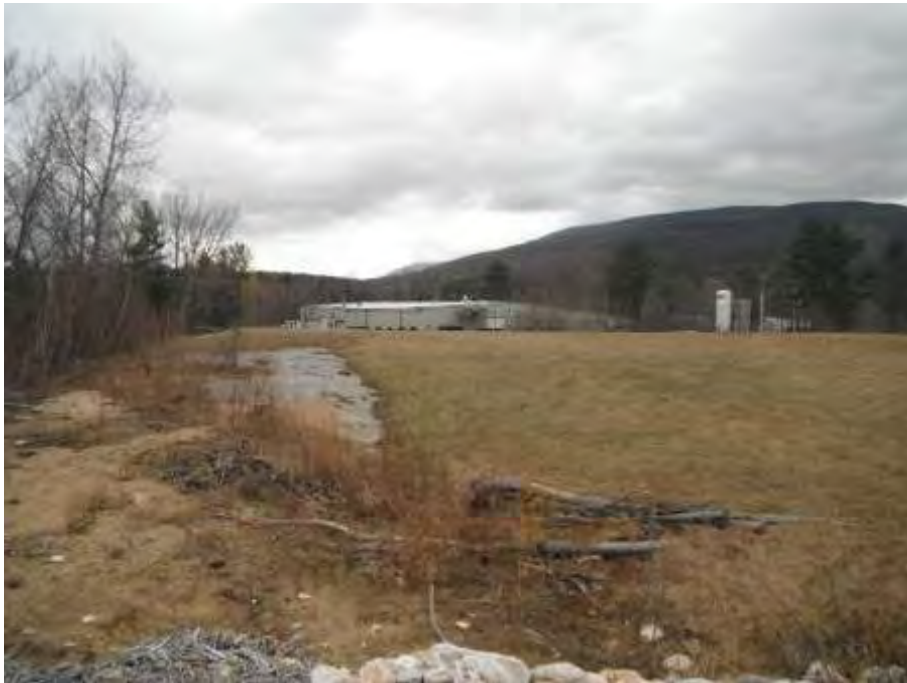
**FRAME NUMBER:** DSCF0553.JPG  
**PHOTOGRAPHY BY:** G. Hornok

**SCENE:** View of the earthen cap on the former Jard facility, from the southwest corner of the property on the Walloomsac River berm. An active industrial facility is visible in the background. There are athletic fields located to the left. Photograph taken facing north.

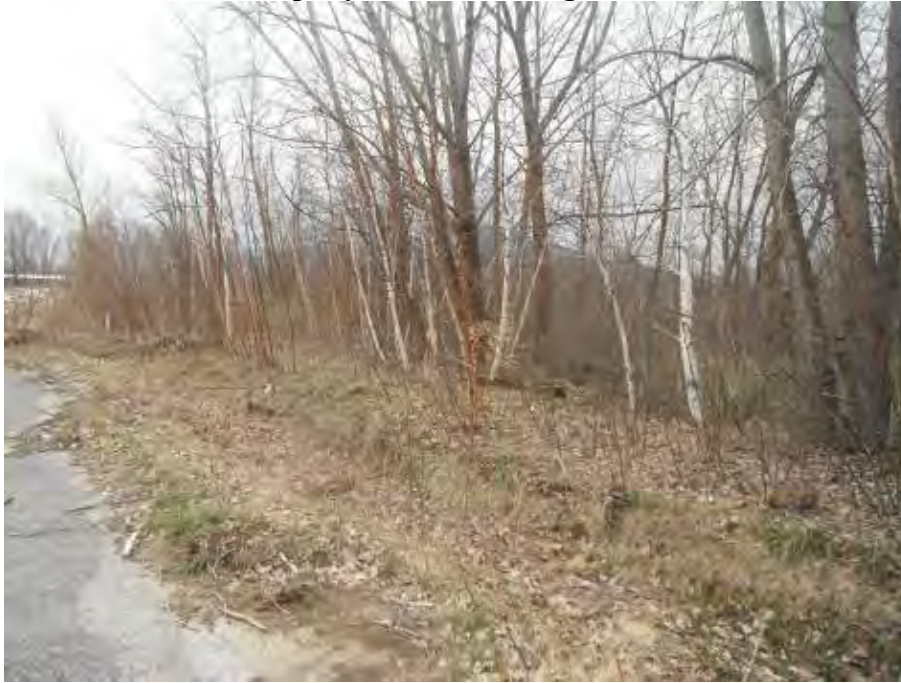
**FRAME NUMBER:** DSCF0613.JPG  
**PHOTOGRAPHY BY:** G. Hornok

**SCENE:** View of the drainage ditch along the western edge of the Jard property. To the right are athletic fields. To the left, there is a small asphalt patch. Several source soil samples were collected within the tree line and drainage ditch to the right. Photograph taken facing south.

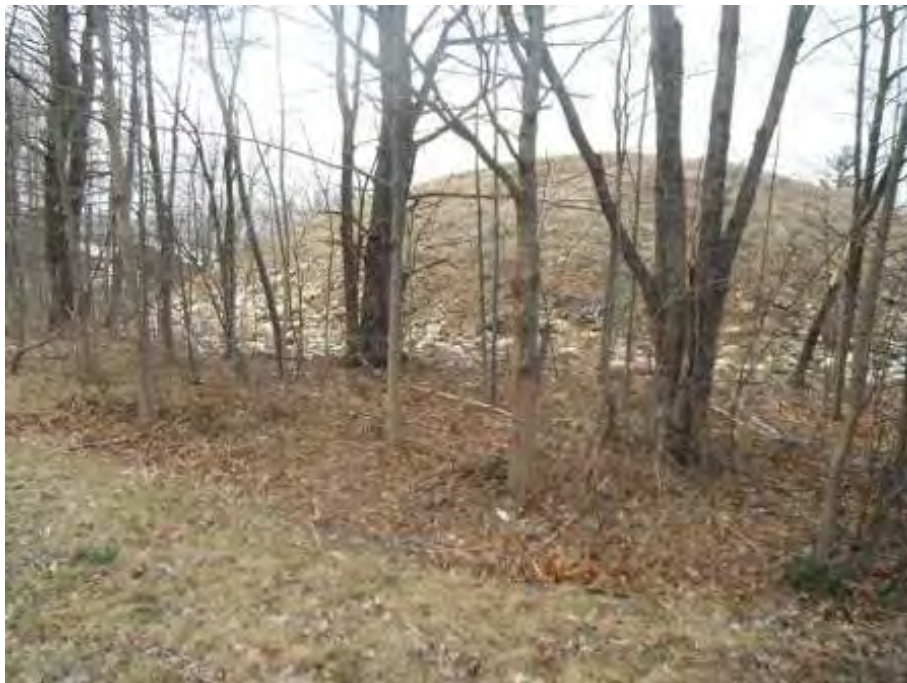
**FRAME NUMBER:** DSCF0618.JPG  
**PHOTOGRAPHY BY:** G. Hornok

**SCENE:** View of the northern face of the excavated material pile along Bowen Road. The former Jard facility property is to the right, and the Vermont Department of Transportation facility is to the left. Photograph taken facing south.

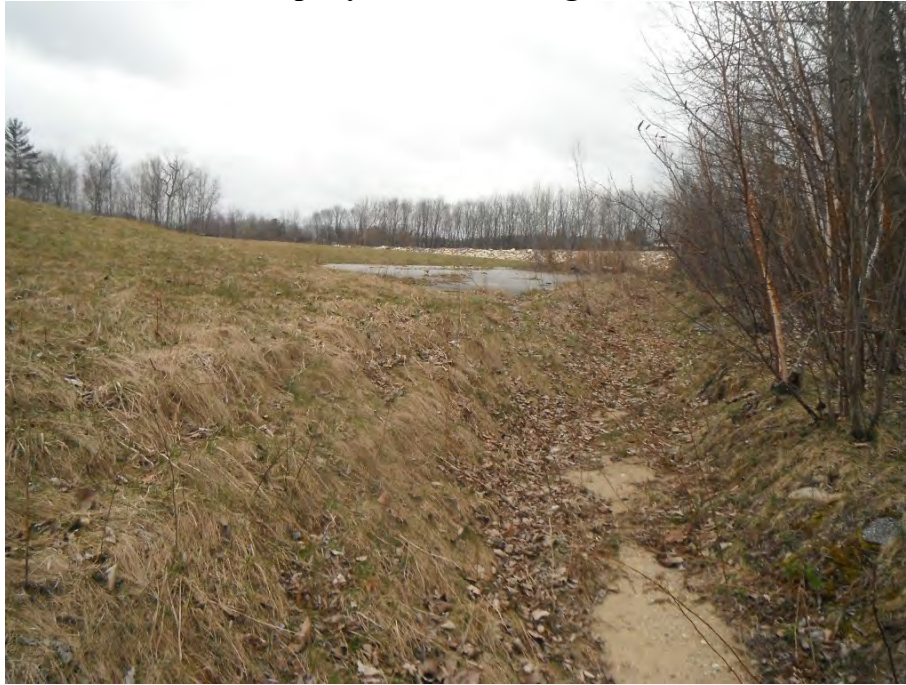
**SCENE:** View of the drainage ditch along the western edge of the Jard property. To the right are athletic fields. In the background, the Walloomsac River berm is visible along with a portion of the earthen cap. Several source soil samples were collected within the tree line and drainage ditch to the right. Photograph taken facing south.

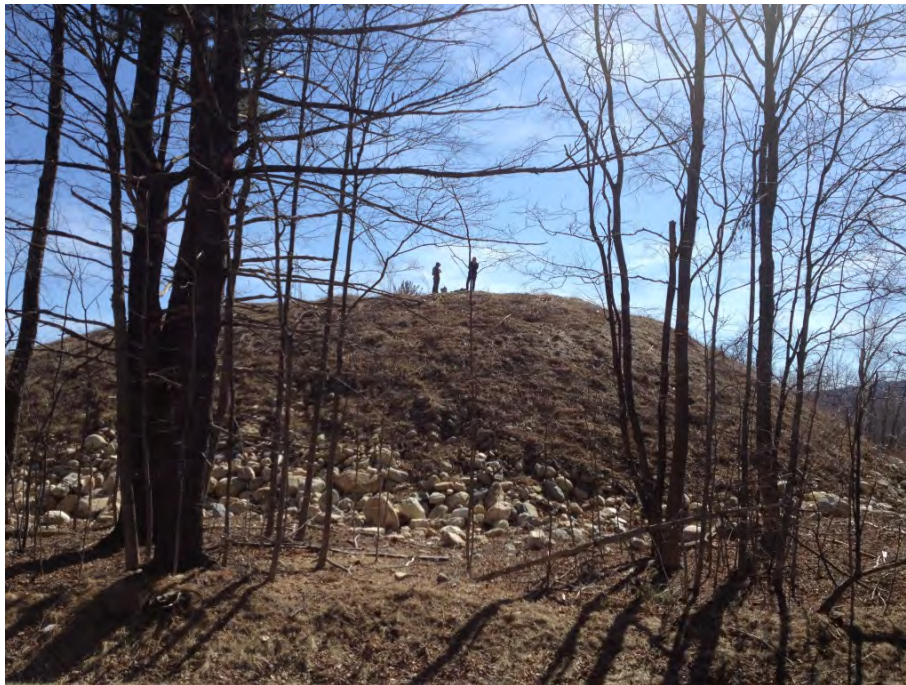
**SCENE:** View of the northern face of the excavated material pile along Bowen Road. The former Jard facility property is to the right, and the Vermont Department of Transportation facility is to the left (not seen in photograph). Photograph taken facing south.

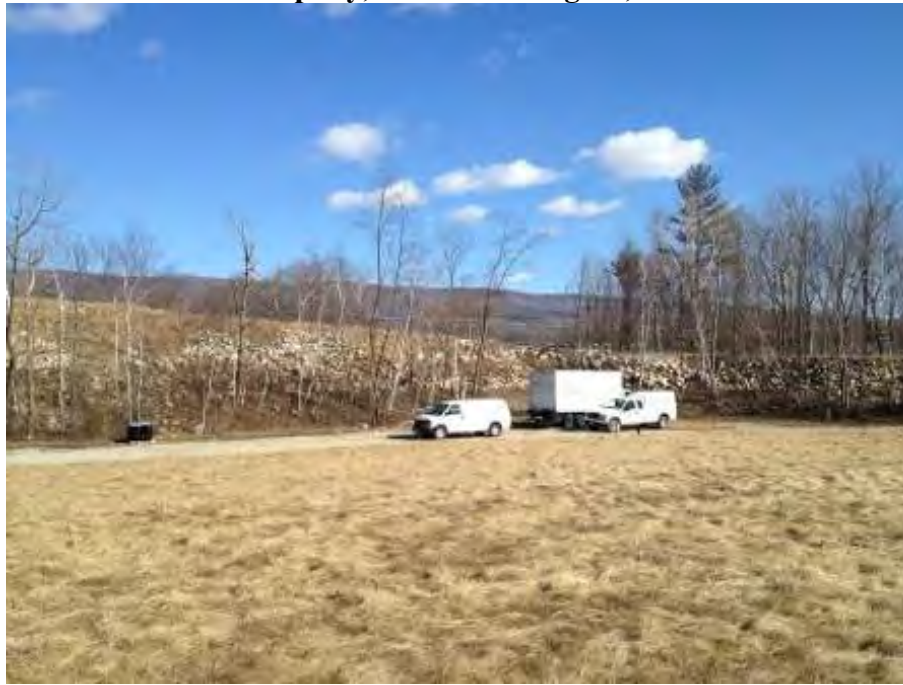
**FRAME NUMBER:** IMG\_0152.JPG  
**PHOTOGRAPHY BY:** G. Hornok

**SCENE:** View of the START staging area utilized during sampling activities, investigative derived waste (IDW) drums, and the western slope of the excavated material pile from the earthen cap overlaying the former Jard facility. The Walloomsac River berm is visible to the right. Photograph taken facing southeast.

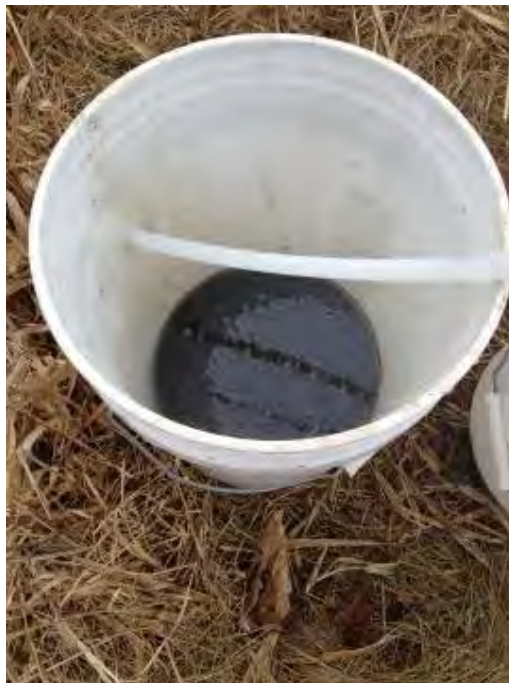
**FRAME NUMBER:** IMG\_0157.JPG  
**PHOTOGRAPHY BY:** G. Hornok

**SCENE:** Close-up view of the purge water extracted from monitoring well MW-3D during well development activities. Note the oily sheen on the water surface. Photograph taken facing south.

START personnel conducted an on-site and off-site reconnaissance of all the previously installed groundwater monitoring wells within the vicinity of the Jard property (see Attachment A, Figure 2B). The purpose of the reconnaissance was to determine the well construction parameters and water depth within each well prior to sampling. The information gathered was used to determine which groundwater monitoring wells would be sampled during the first week in April. All of the intact/viable monitoring wells were located, documented with the GPS, and water level and total depths recorded. On 28 March 2013, four wells were developed using a Waterra system. Purge water from three of the monitoring wells located on the Jard property contained oil sheen. All development purge water was containerized as IDW within drums secured on the property.

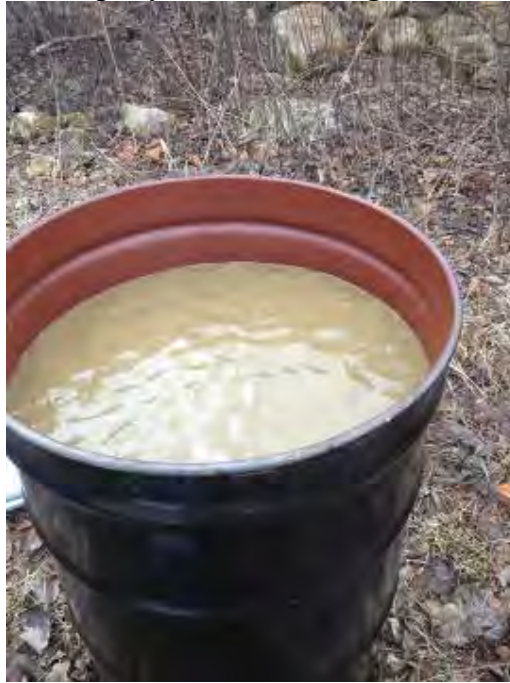
**FRAME NUMBER:** IMG\_0159.JPG  
**PHOTOGRAPHY BY:** G. Hornok

**SCENE:** View of a drum containing IDW generated from monitoring well development. Drums were staged at the edge of an asphalt patch to the west of the excavated material pile. Note the oily sheen on the water surface. Photograph taken facing east.

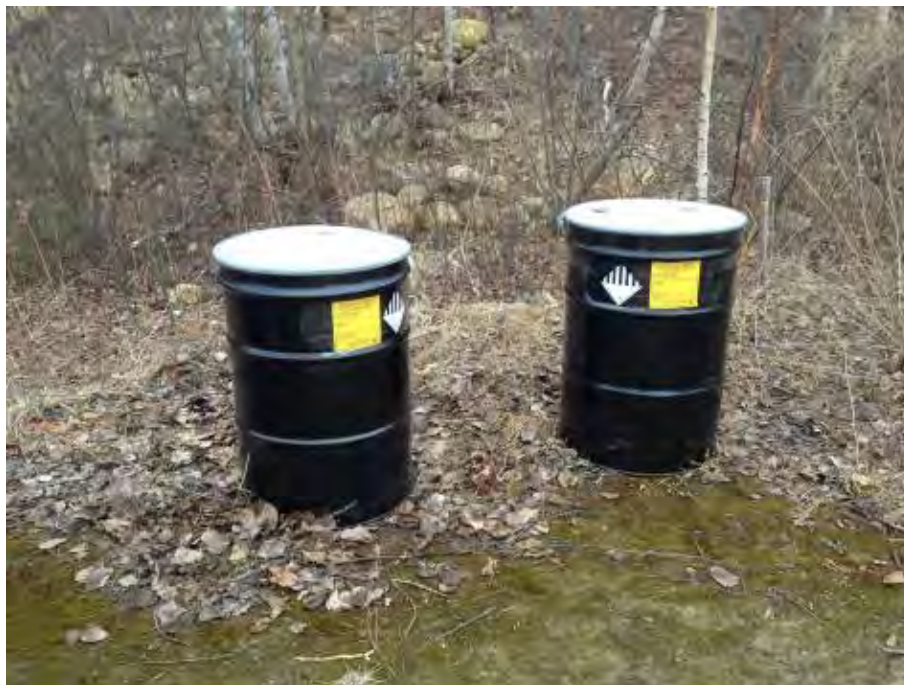
**FRAME NUMBER:** IMG\_0160.JPG  
**PHOTOGRAPHY BY:** G. Hornok

**SCENE:** View of two labeled drums used to containerize IDW generated by well development activities. The edge of the excavated material pile is visible in the background. Photograph taken facing east.

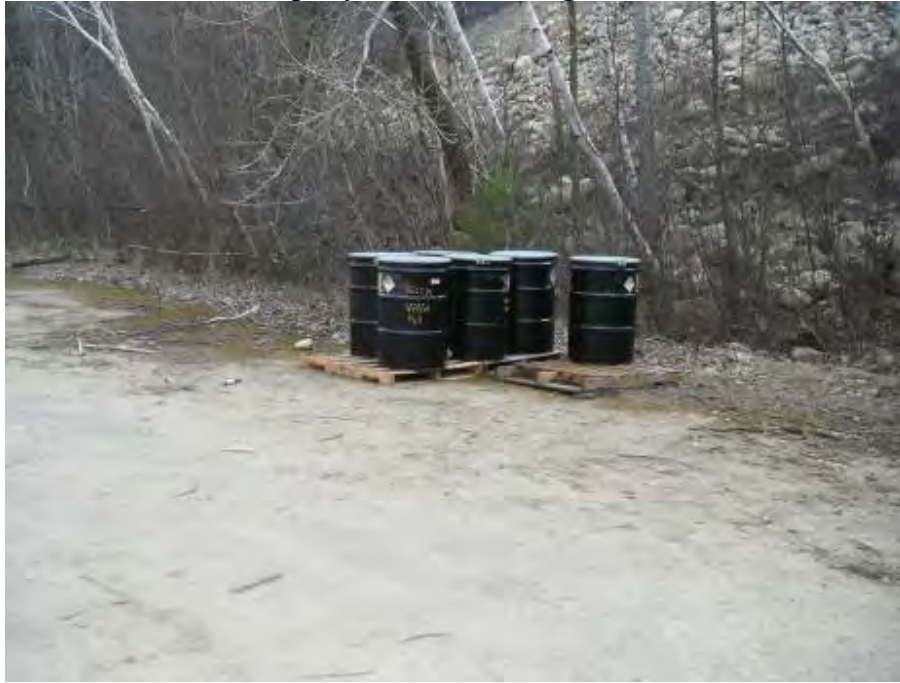
**SCENE:** View of six labeled stainless steel 55-gallon drums staged on wooden pallets and containing IDW generated by well development, sampling activities, and decontamination of equipment. The edge of the excavated material pile is visible in the background. Photograph taken facing northeast.

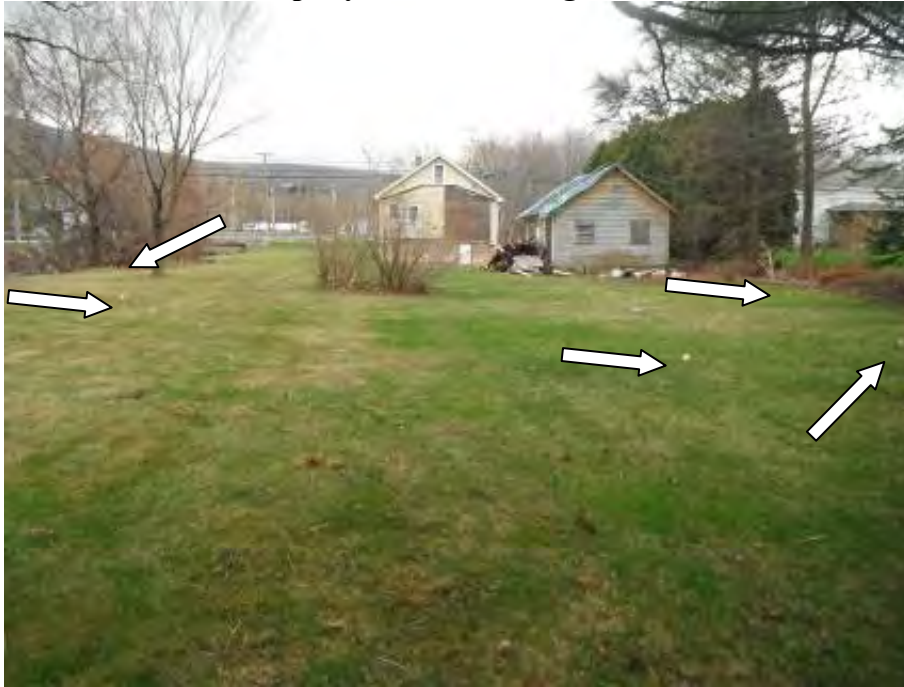
**FRAME NUMBER:** DSCF0588.JPG  
**PHOTOGRAPHY BY:** G. Hornok

**SCENE:** View of the backyard, a storage shed, and the rear façade of Property P001. Sample locations, demarcated by white pin-flags, are visible in the grassy area. Sample locations from left to right are: P001-SS-08 (adjacent to stream), P001-SS-02, P001-SS-04 (in foreground), P001-SS-06, and P001-SS-05. Park Street is visible in the background. Photograph taken facing east.

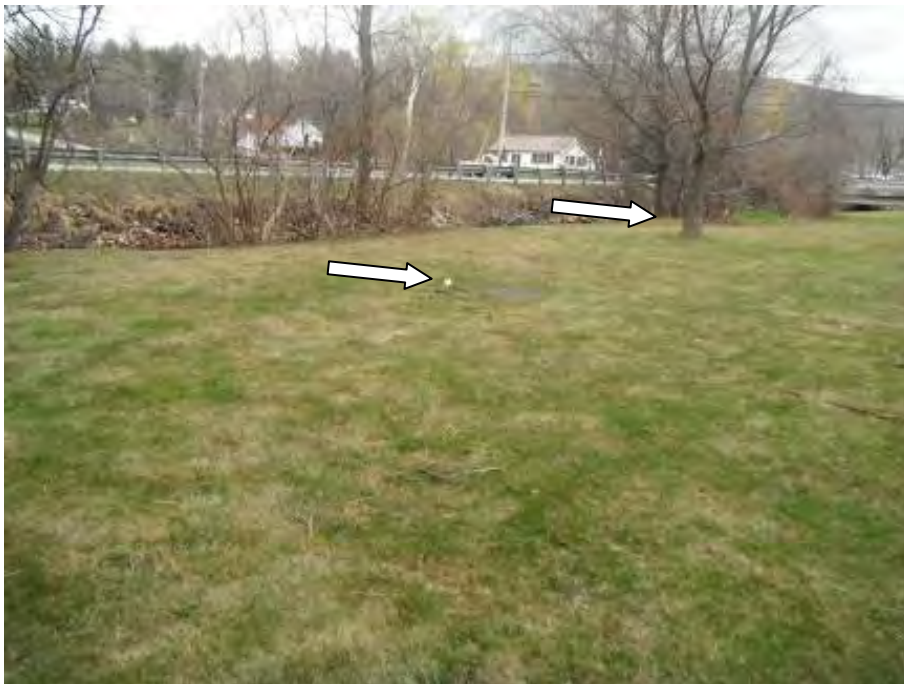
**FRAME NUMBER:** DSCF0590.JPG  
**PHOTOGRAPHY BY:** G. Hornok

**SCENE:** View of the stream along the northern edge of Property P001. Sample location P001-SS-02 is visible adjacent to the manhole cover. Sample location P001-SS-08 is visible in the background near the stream. Photograph taken facing northeast.

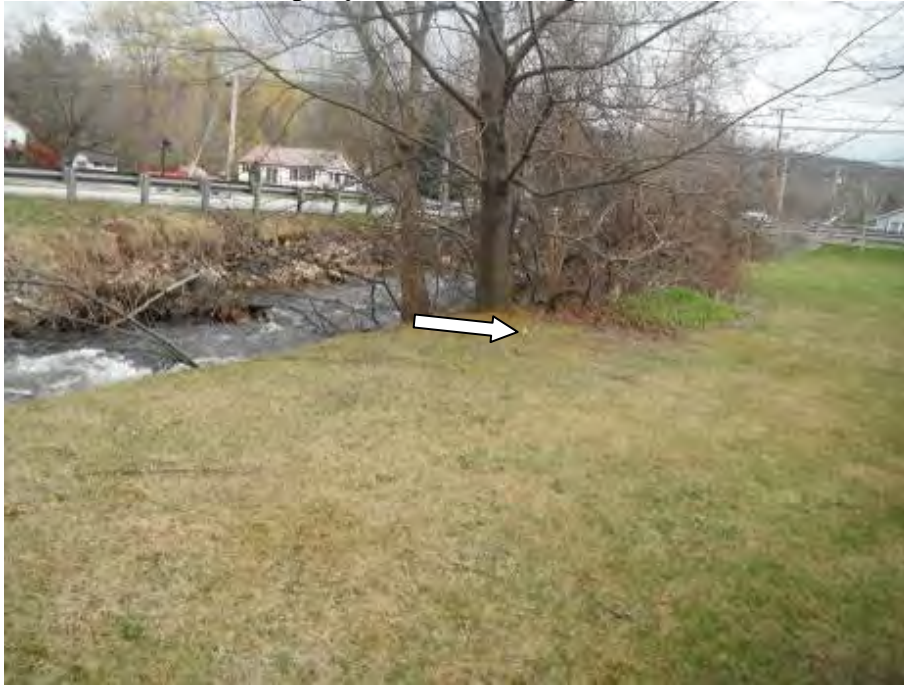
**FRAME NUMBER:** DSCF0591.JPG  
**PHOTOGRAPHY BY:** G. Hornok

**SCENE:** View of the stream along the northern edge of Property P001. Sample location P001-SS-08 is visible in the center of the photograph. The intersection of Park Street and Kocher Drive is visible in the background. Photograph taken facing northeast.

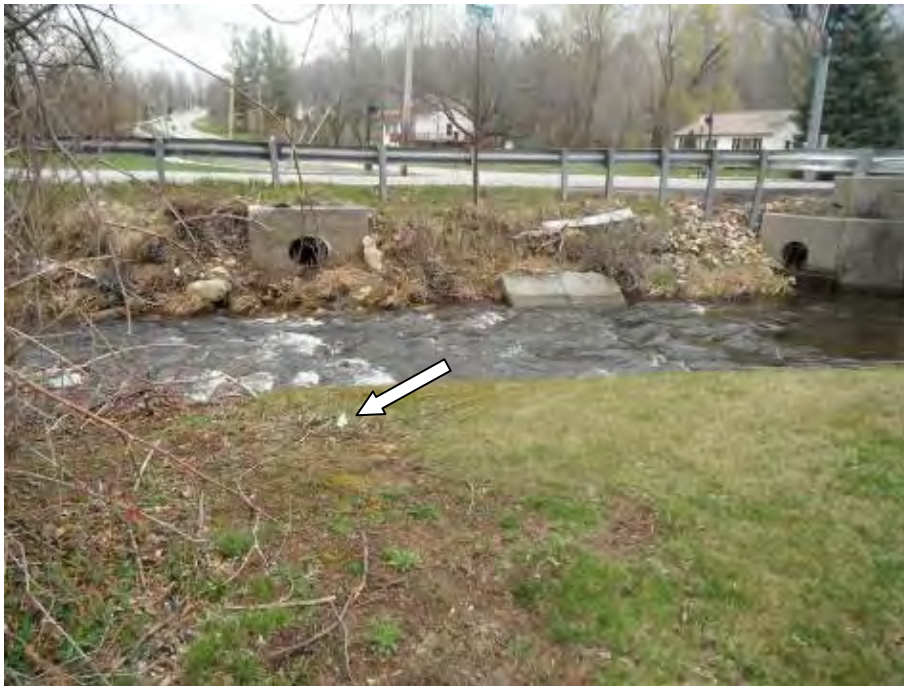
**FRAME NUMBER:** DSCF0594.JPG  
**PHOTOGRAPHY BY:** G. Hornok

**SCENE:** View of the stream and multiple culverts north of Property P001 and south of Kocher Drive. Sample location P001-SS-10 is demarcated by a white pin-flag. Kocher Drive and Park Street are visible in the background. Photograph taken facing north.

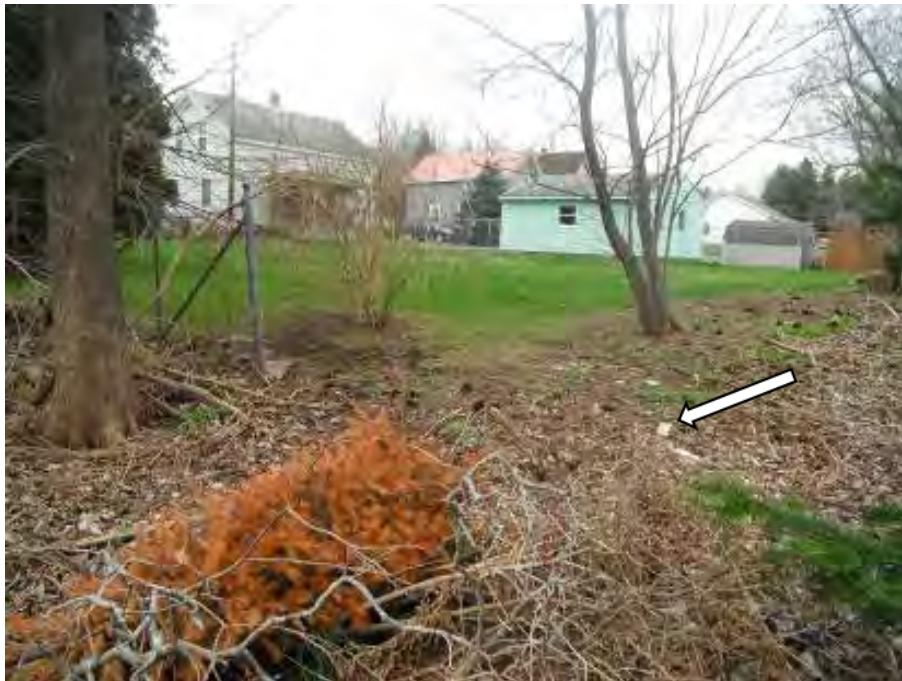
**FRAME NUMBER:** DSCF0595.JPG  
**PHOTOGRAPHY BY:** G. Hornok

**SCENE:** View of the backyard of Property P002 from the northwest corner of the property. Sample location P002-SS-07 is visible in the foreground. Photograph taken facing south.

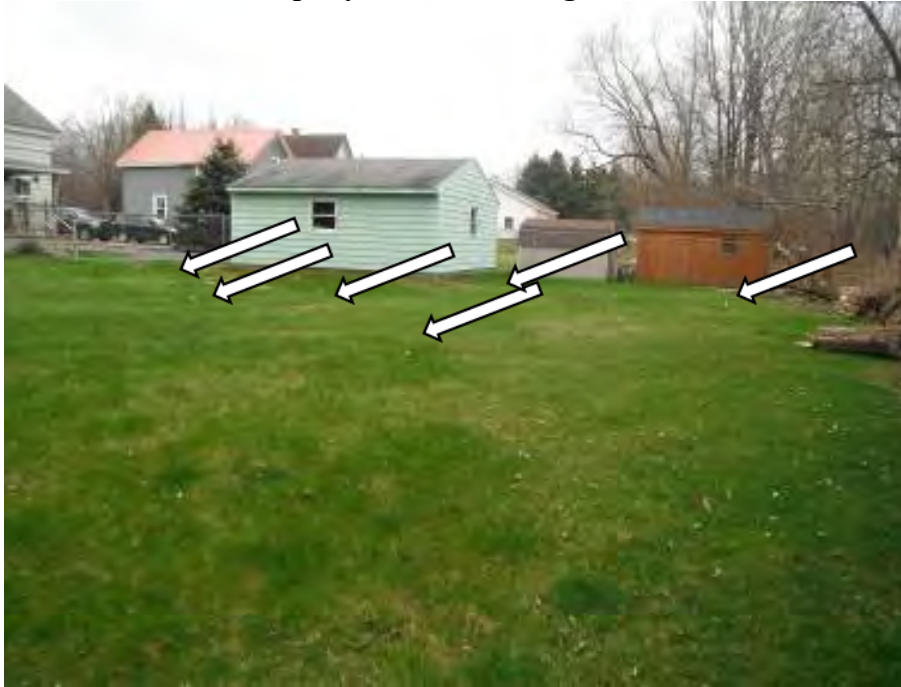
**FRAME NUMBER:** DSCF0596.JPG  
**PHOTOGRAPHY BY:** G. Hornok

**SCENE:** View of the backyard and garage of Property P002. Multiple sample locations are visible; from left to right they are: P002-SS-03, P002-SS-06, P002-SS-02, P002-SS-08, P002-SS-09, and P002-SS-01. The residence is visible to the far left; the property boundary is defined by the chain-link fence. Photograph taken facing south.

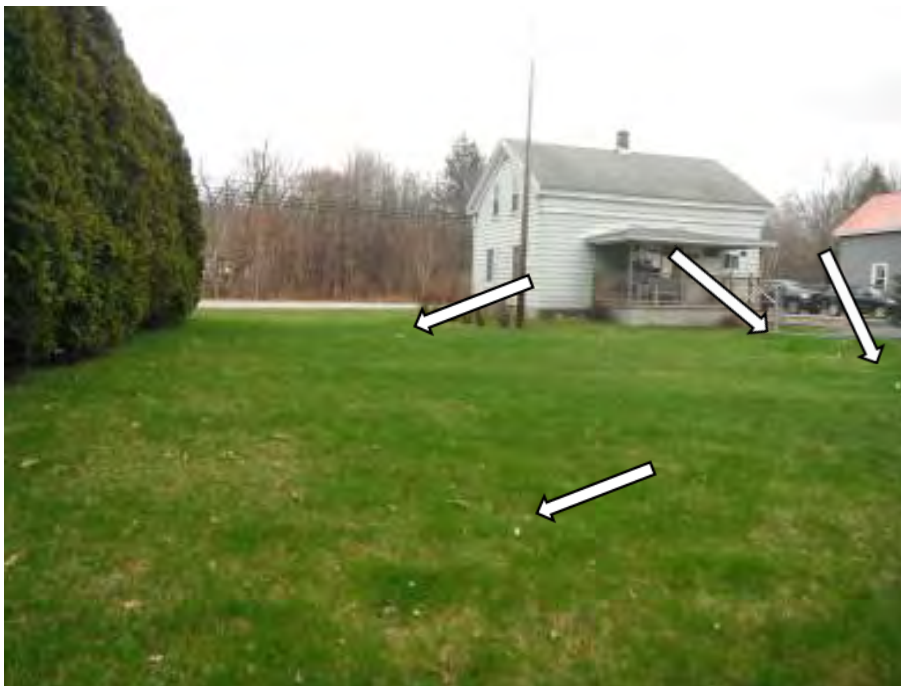
**FRAME NUMBER:** DSCF0597.JPG  
**PHOTOGRAPHY BY:** G. Hornok

**SCENE:** View of the backyard and rear façade of the residence of Property P002. Several sample locations are visible; from left to right: P002-SS-10, P002-SS-04, P002-SS-03, and P002-SS-06. Photograph taken facing east.

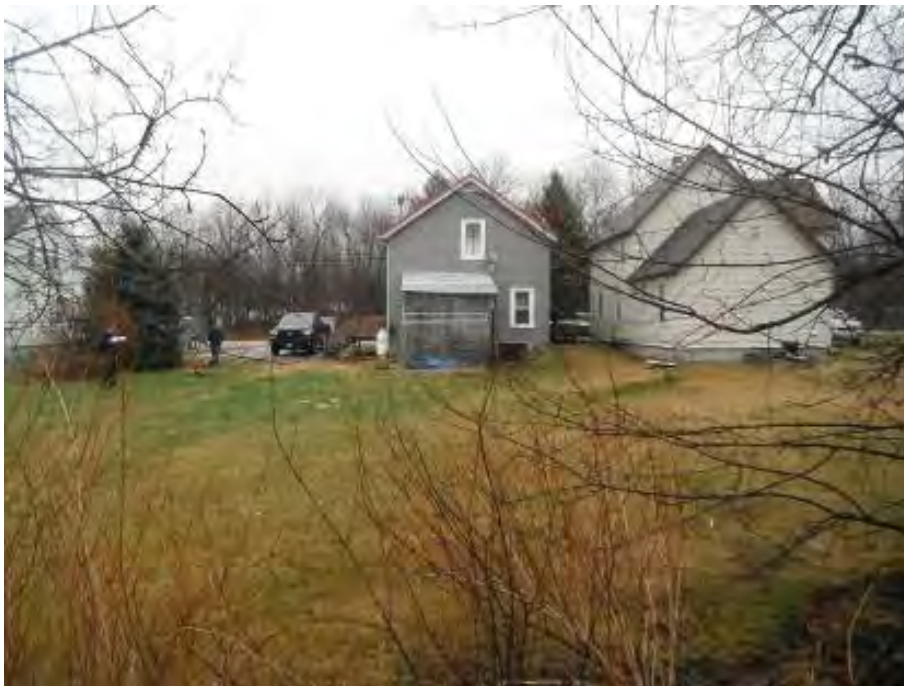
**FRAME NUMBER:** DSCF0458.JPG  
**PHOTOGRAPHY BY:** G. Hornok

**SCENE:** View of the back yard and house of Property P003. Several sample locations are visible in the backyard of Property P003, indicated by white pin-flags. Photograph taken from the sample location P003-SS-04, facing east.

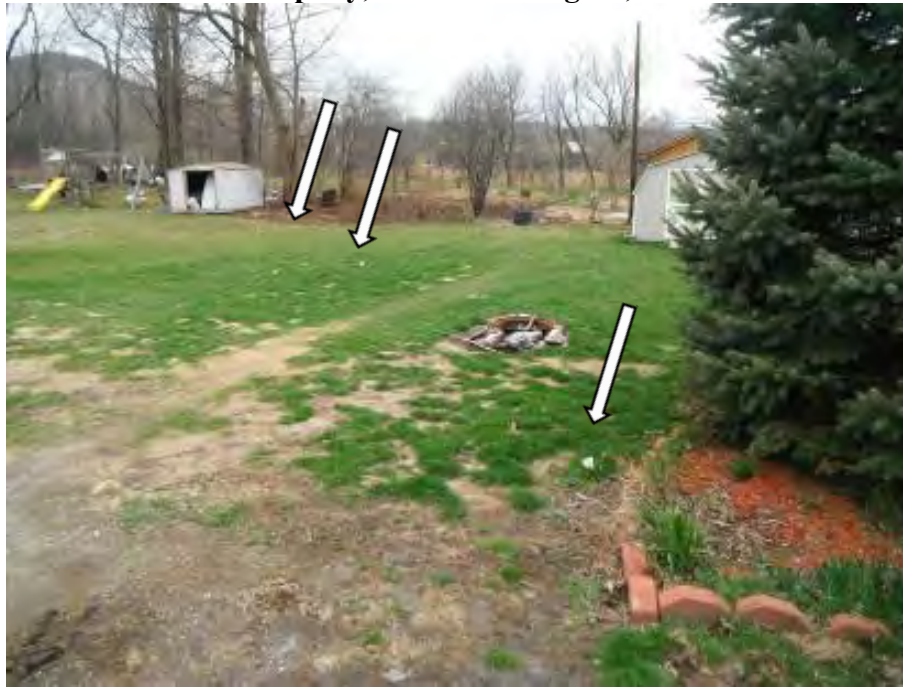
**FRAME NUMBER:** DSCF0480.JPG  
**PHOTOGRAPHY BY:** J. Saylor

**SCENE:** View of the western portion of Property P003. The horse paddock area is visible in the background. From the foreground to the background, sample locations P003-SS-10 and P003-SS-06 are visible in the grassy area indicated by white pin-flags; sample location P003-SS-04 is visible in the brushpile near the property boundary and horse paddock. Photograph taken facing west.

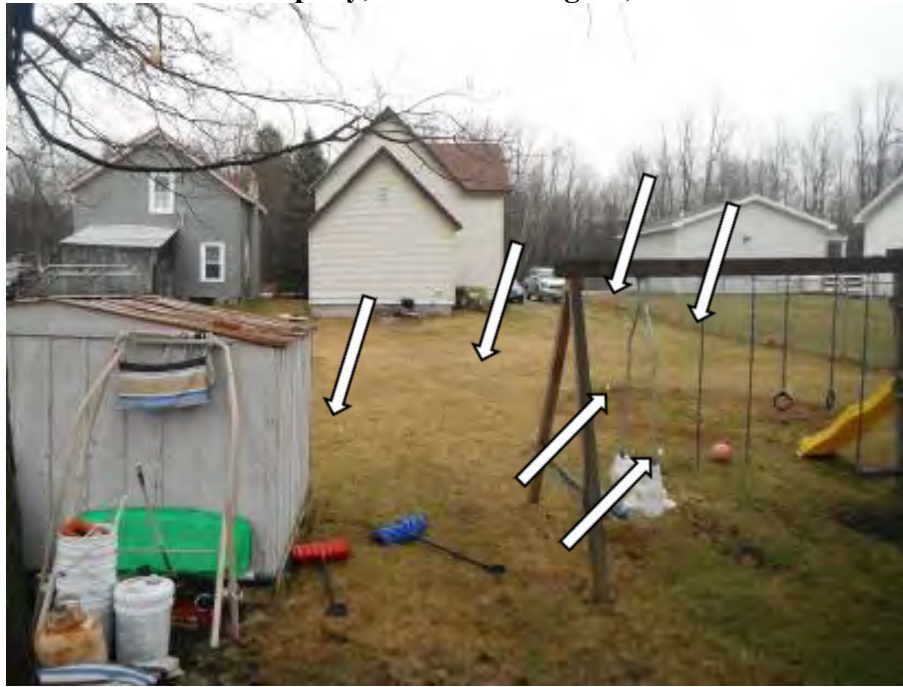
**FRAME NUMBER:** DSCF0457.JPG  
**PHOTOGRAPHY BY:** G. Hornok

**SCENE:** View of the backyard of Property P004. The shed and swing-set are visible in the foreground. Surface soil sample locations are visible, indicated by white pin-flags. From left to right, the locations are identified as: P004-SS-06, P004-SS-02, P004-SS-04, P004-SS-09, P004-SS-05, and P004-SS-10. Photograph taken facing east.

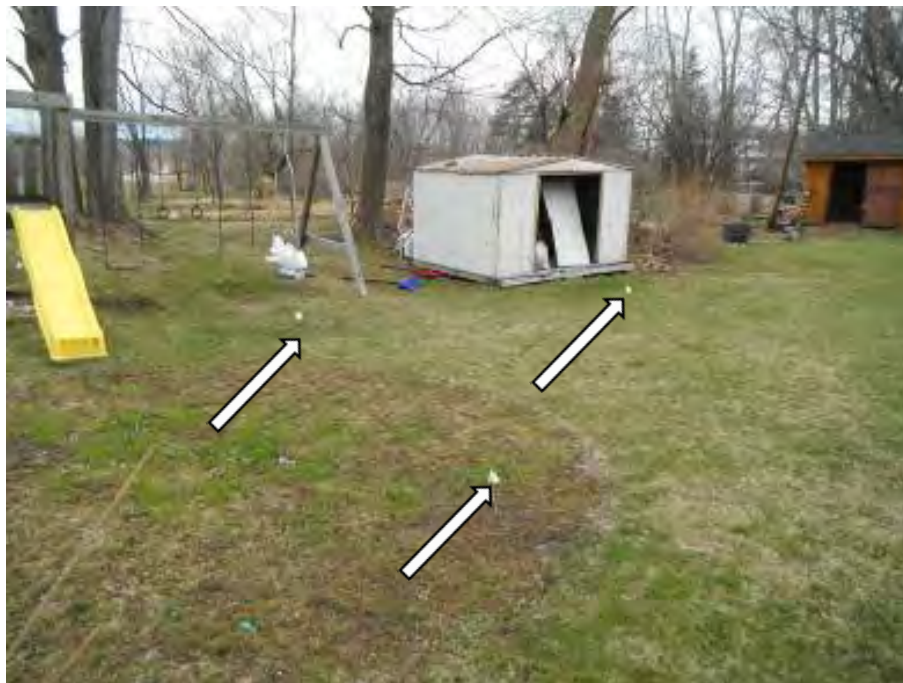
**FRAME NUMBER:** DSCF0490.JPG  
**PHOTOGRAPHY BY:** J. Saylor

**SCENE:** View of the western edge of Property P004. In the background the swing-set, shed, and horse stable are visible. There are several surface soil locations visible. From left to right, these sample locations are identified as: P004-SS-09, P004-SS-04, and P004-SS-06. Photograph taken facing northwest.

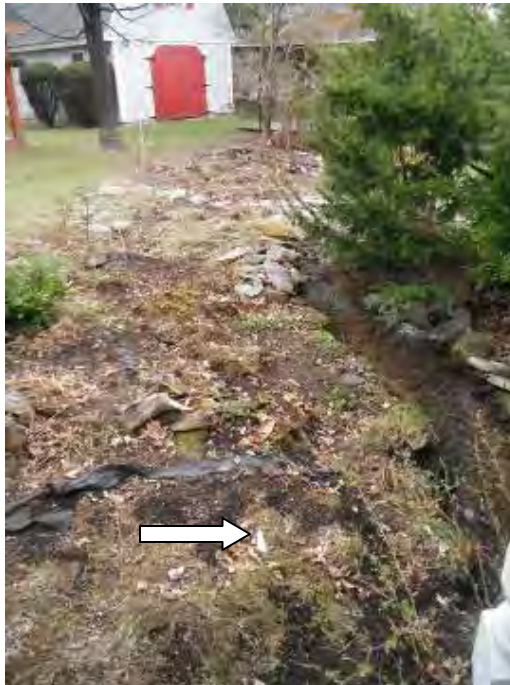
**FRAME NUMBER:** DSCF0494.JPG  
**PHOTOGRAPHY BY:** J. Saylor

**SCENE:** View of the streambed on Property P005 where sediment samples were collected. Sample location P005-SS-03 is visible in the foreground, and a large shed is visible in the background. Photograph taken from footbridge facing northwest.

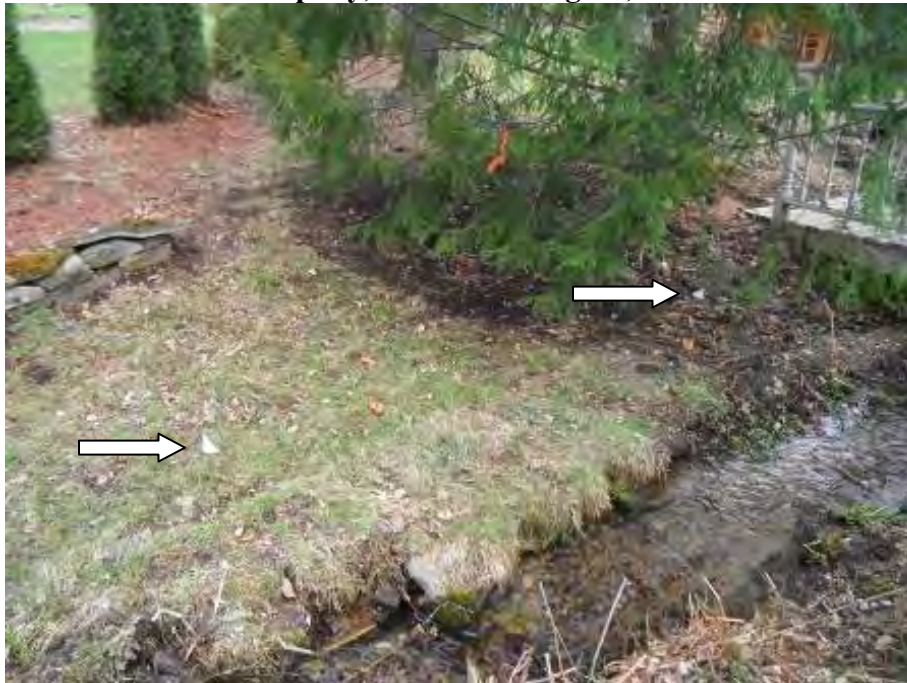
**FRAME NUMBER:** DSCF0495.JPG  
**PHOTOGRAPHY BY:** J. Saylor

**SCENE:** View of a streambed along the southern boundary of Property P005. Surface soil sample location P005-SS-02 is visible in the lower left (lower arrow) of the photograph adjacent to the streambed. Sediment sample location SD-38 within the streambed is indicated by the orange flagging and white pin flag (upper arrow). Photograph taken facing southwest.

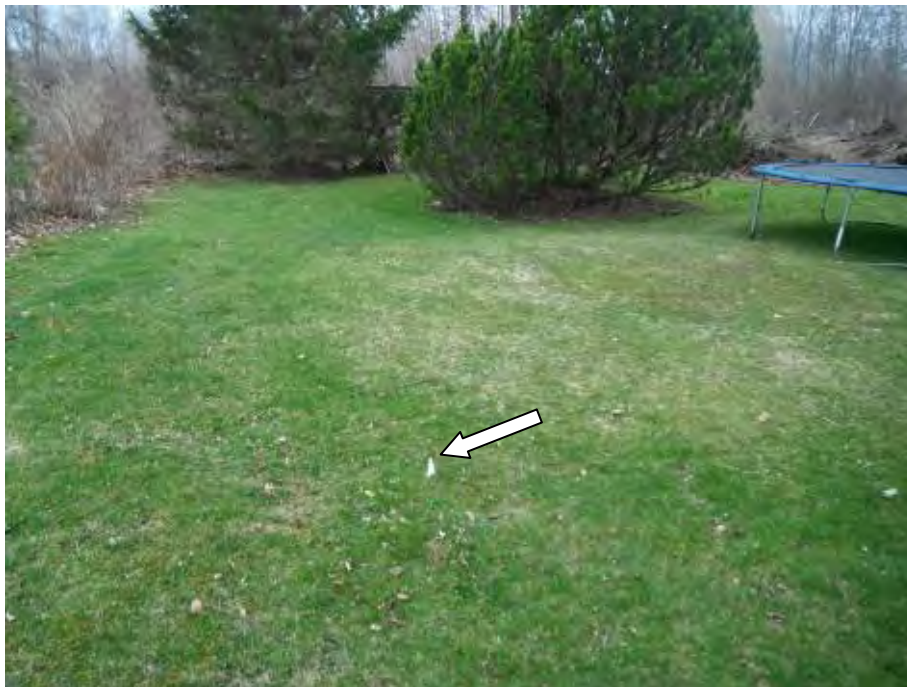
**FRAME NUMBER:** DSCF0498.JPG  
**PHOTOGRAPHY BY:** J. Saylor

**SCENE:** View of the western boundary of Property P005. Surface soil sample location P005-SS-09 is visible in the foreground. The potentially impacted wetlands are visible in the background. Photograph taken facing northwest.
